Proven Approaches to Machinery Analysis Success

Emerson's PeakVue™ technology cuts through the complexity of machinery analysis to enable faster, more informed decisions.

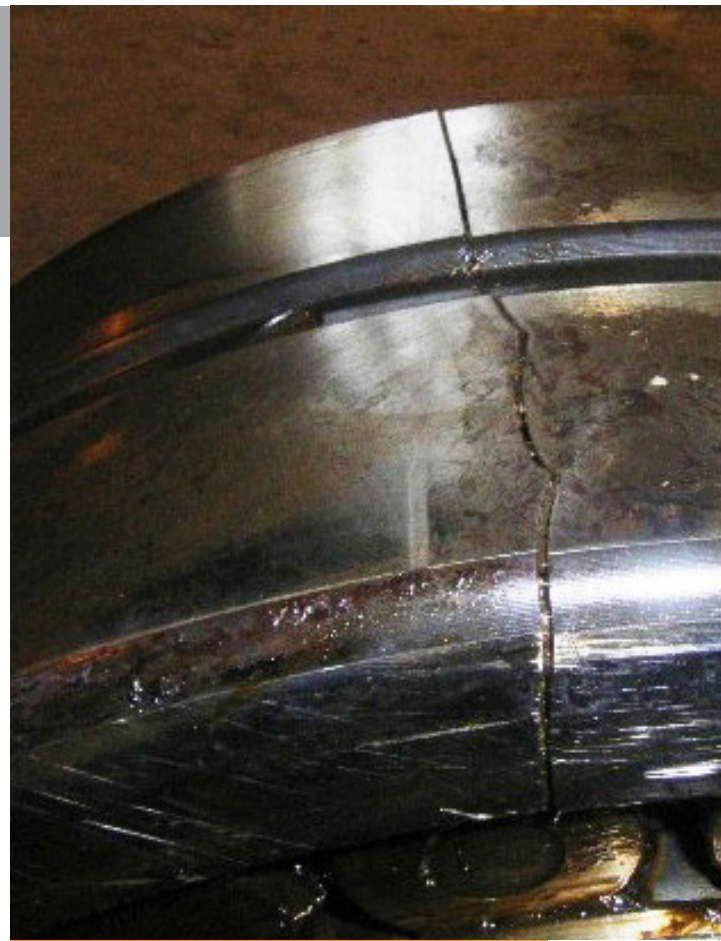
A bearing crack detected using PeakVue data would likely have led to a sudden failure and an extended unplanned outage.

Based on the PeakVue data and multi-spectra views, the team discovered a developing bearing fault and was immediately able to pinpoint its location. It was clear that an essential bearing was cracked and flaking. Though the repair required the plant stop production for 12 hours, had the fault gone undetected it likely would have led to a sudden failure that caused additional damage and took much longer to repair. The planned shutdown was a far better solution.

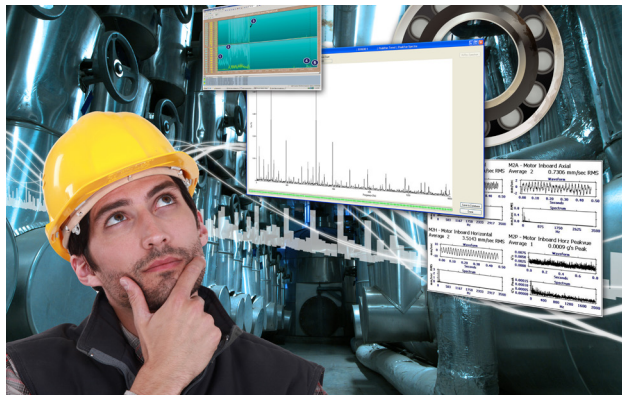
Noting indications of impacting in the data, the technician touched the screen to initiate the embedded expertise of PeakVue Plus analytics. The PeakVue Plus color bars indicated that the fan was properly oiled. The bearing/mechanical bar at the top, however, indicated that the fan could be experiencing periodic impacting, potentially related to a late-stage bearing issue.

Even with little analysis experience, the technician recognized that the PeakVue Plus information and an associated trend plot strongly indicated a moderate mechanical issue. The technician changed the monitoring frequency of the fan to weekly versus monthly so the asset would be monitored closely.

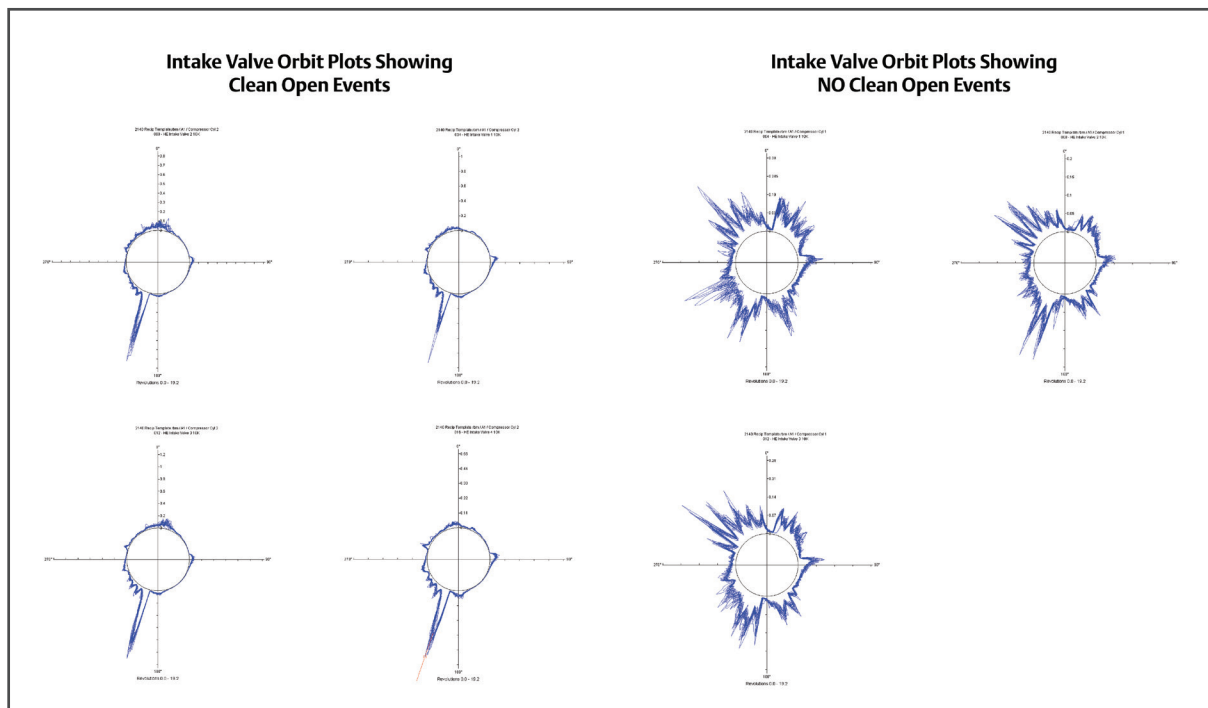
The polar plot, on the left, shows healthy compressor-valve operation with clean open signatures on both intake and exhaust events (intake only shown here). The signature on the right indicates leaking rings or gas blowby.

Any technician—regardless of vibration analysis training—could see if the compressor had changed for the worse. After collecting data and reviewing plots (Figure 1), the technician then could perform preliminary troubleshooting and call in an expert if needed. With this early warning, the team could avoid an unplanned shut down.
