REPORT NO.: T70487-01  
 WYLE JOB NO.: T70487  
 CLIENT P.O. NO.: 4125051593  
 CONTRACT: N/A  
 TOTAL PAGES (INCLUDING COVER): 27  
 DATE: December 4, 2012

**TEST REPORT**  
**ENVIRONMENTAL TESTING**  
**ON**  
**ONE GVO LINEAR VALVE OPERATOR**  
**FOR**  
**EMERSON PROCESS MANAGEMENT**  
**WYLE REPORT NO. T70487-01**

This report documents the test procedures followed to qualify GVO series actuator (2" to 54" pneumatic/hydraulic) with similar seals arrangement for IP66M and IP67M, and the results obtained during Environmental testing performed on one GVO Linear Valve Operator for Emerson Process Management. Testing was performed at Wyle Laboratories' Huntsville, Alabama, Test Facility from November 2 through November 24, 2012. A

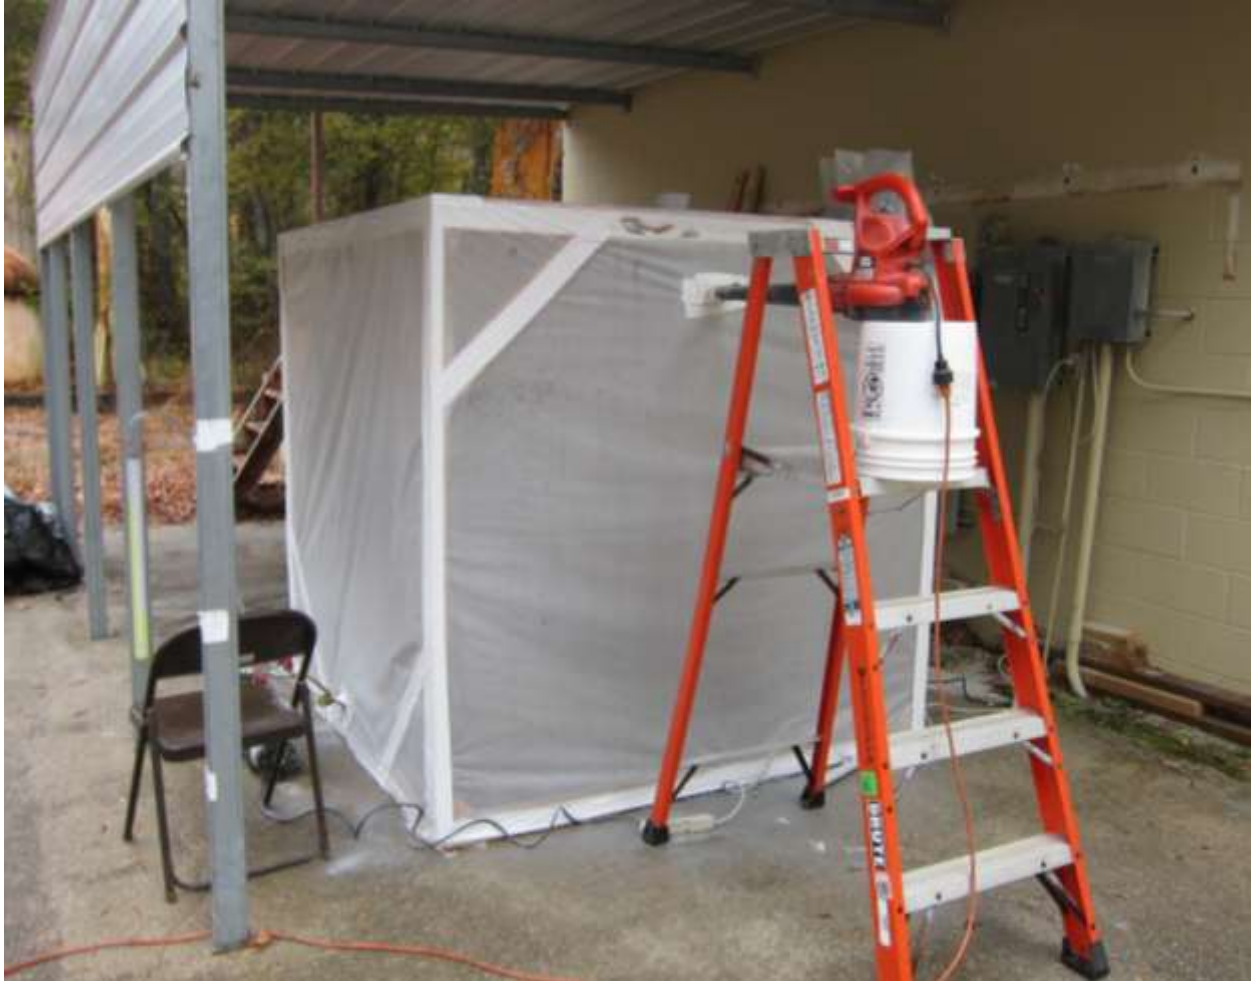
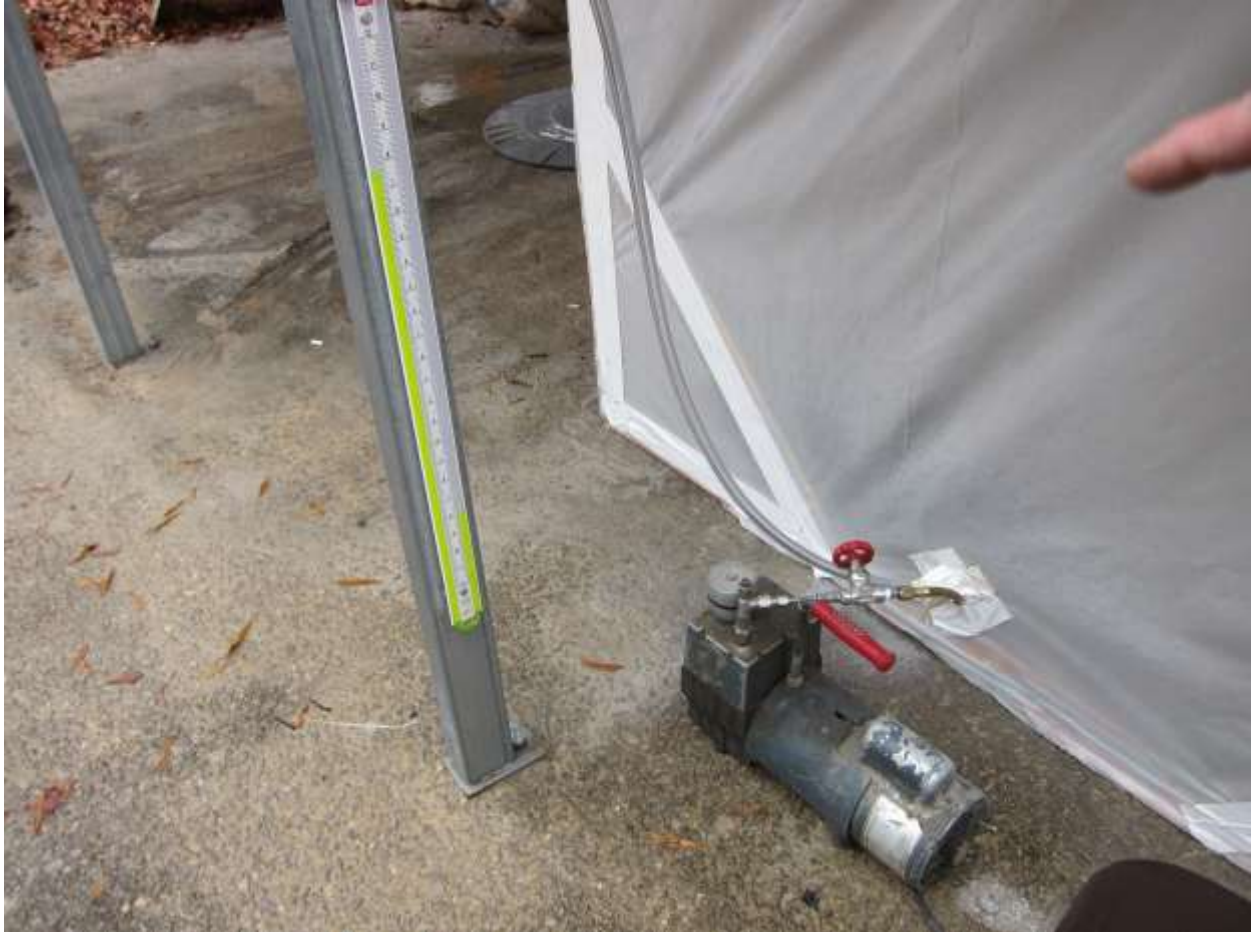
**Photograph No. 1**  
**Protection Against Solid Foreign Objects (Dust-Tight) Test Setup**

**Photograph No. 2**  
**Protection Against Solid Foreign Objects (Dust-Tight) Test Setup**

The UUT was placed inside an enclosed Dust Test Chamber that measured approximately 6' (length) by 6' (width) by 6' (height) (216 cubic feet). The required talcum powder concentration was 2 kilograms per cubic meter of the test chamber volume (measuring 26.4 pounds). A circulating fan was used to hold the talcum powder in suspension. An electric blower was used to blow approximately three pounds of talcum powder into the enclosure every 60 minutes throughout the test to maintain the talcum powder concentration. A vacuum pump was attached to the UUT in order to maintain a maximum depression of 2 kPa (20 mbar) to maintain the pressure inside the UUT below the surrounding atmospheric pressure. The total duration of the test was eight hours.

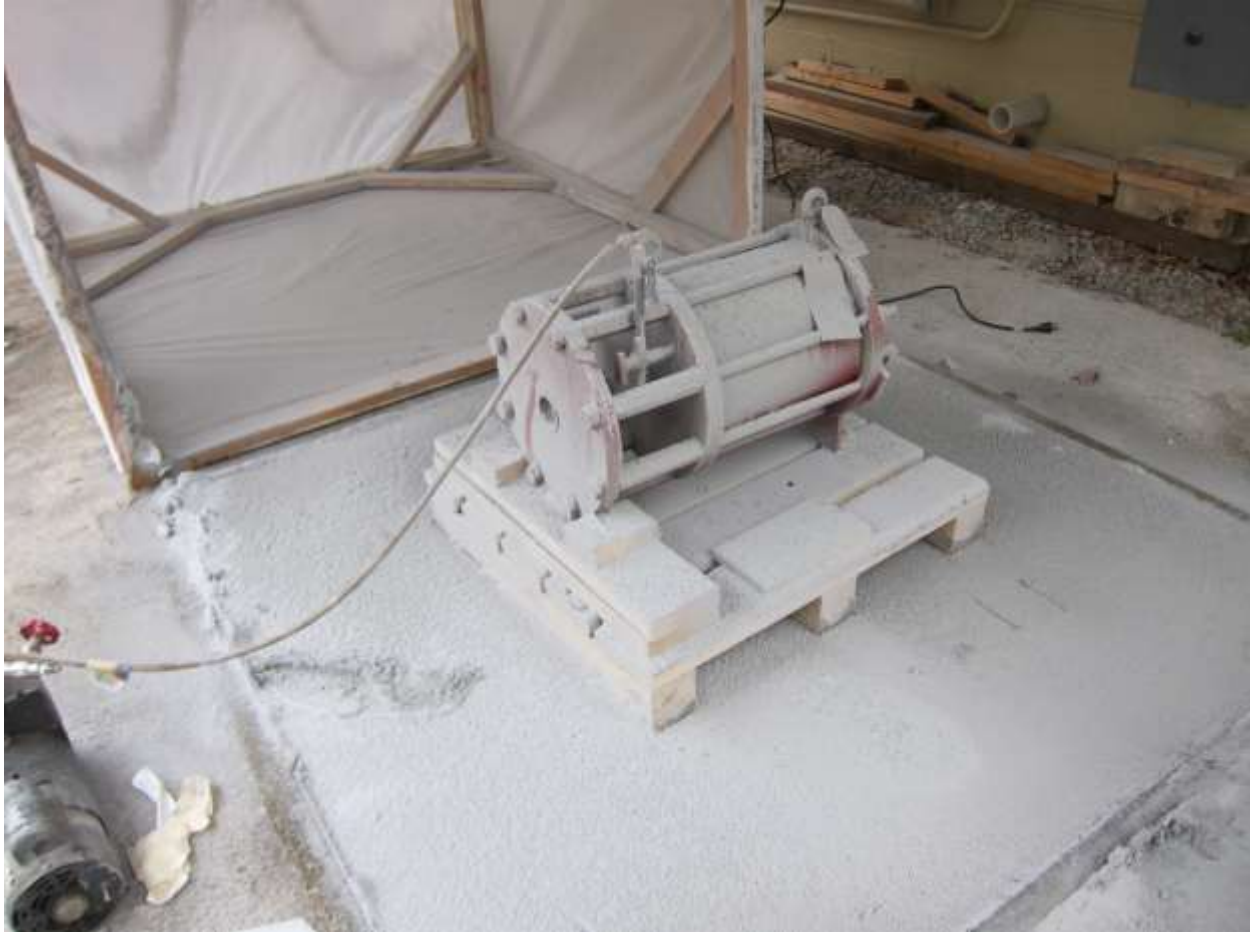
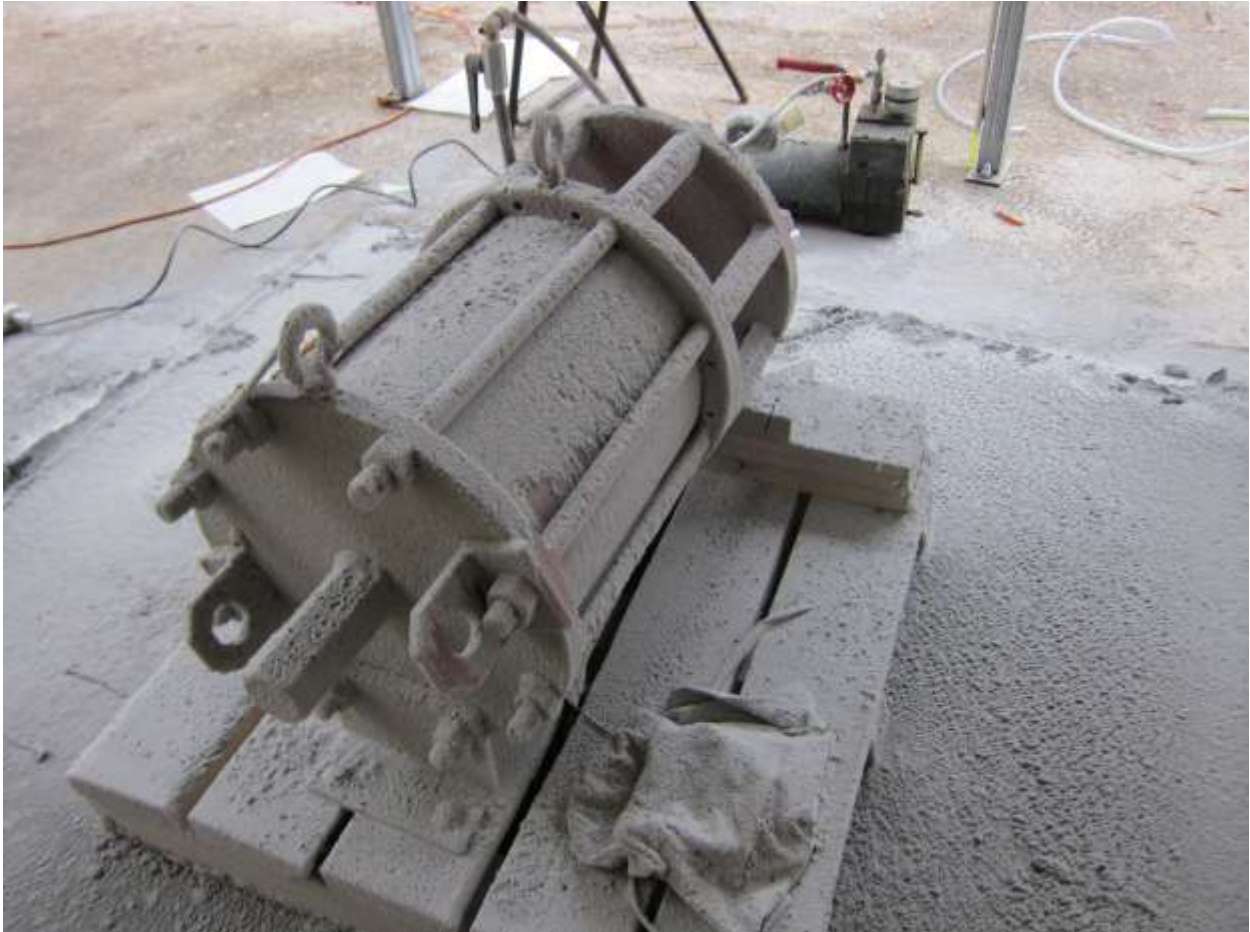
**Photograph No. 3**  
**Protection Against Solid Foreign Objects (Dust-Tight) Test Setup**  
**(Post-Test Appearance)**

**Photograph No. 4**  
**Protection Against Solid Foreign Objects (Dust-Tight) Test Setup**  
**(Post-Test Appearance)**

A post-test visual inspection and an operational check were performed to verify satisfactory post-test conditions of the UUT. The UUT received approximately 50 psi of air pressure to move the UUT from its closed position to its open position. No damages were noted. No anomalies were recorded. The UUT successfully met the Protection Against Solid Foreign Objects (Dust-Tight) Test requirements.

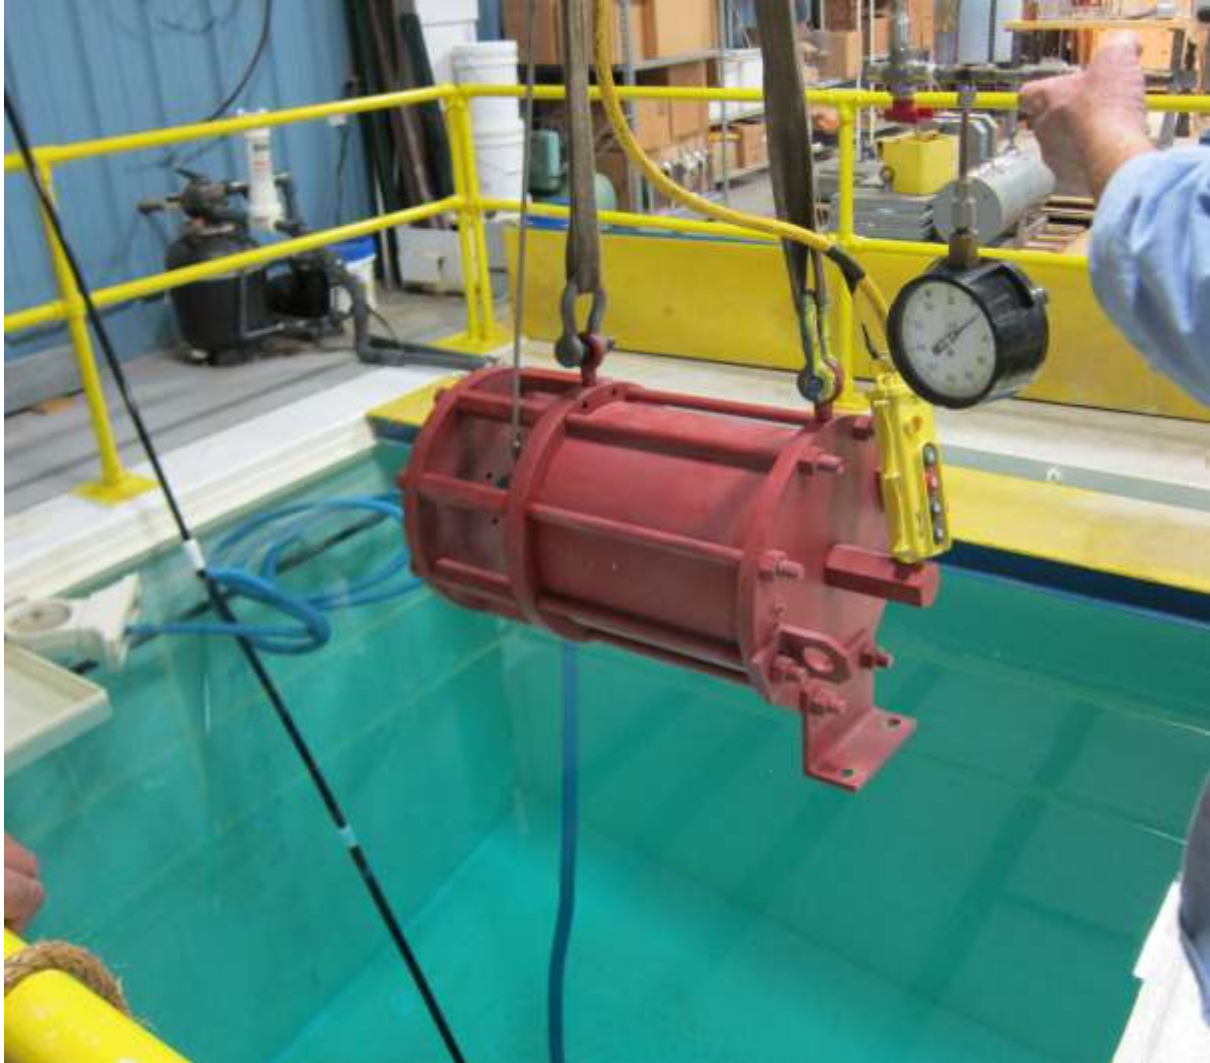
**Photograph No. 5**  
**Protection Against Ingress of Water (IP67M) Test Setup**

**Photograph No. 6**  
**Protection Against Ingress of Water (IP67M) Test Setup**

The UUT was configured in its operational configuration and immersed approximately 20 inches (0.5 meters) in water for 30 minutes. The UUT was operated at various times during the 30-minute exposure.

A post-test operational check was conducted on the UUT. No damages were noted. No anomalies were recorded. The UUT successfully met the Protection Against Ingress of Water (IP67M) Test requirements.

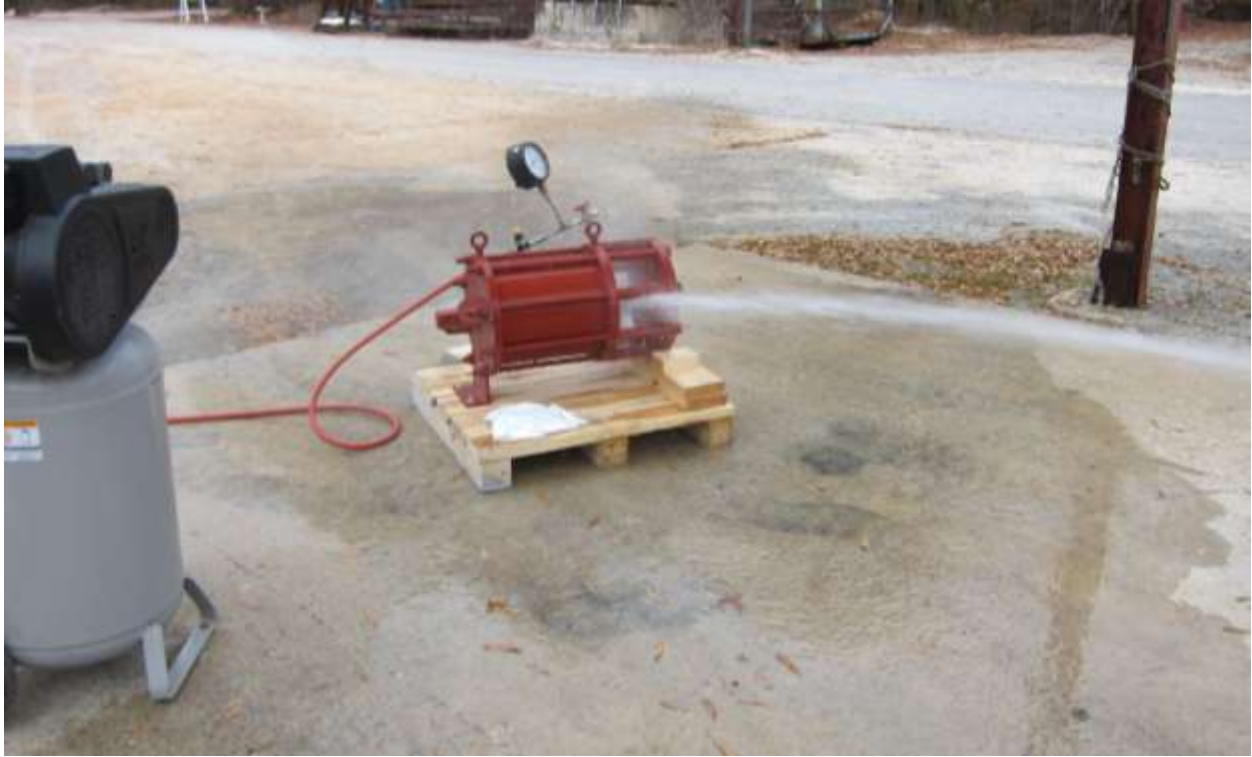
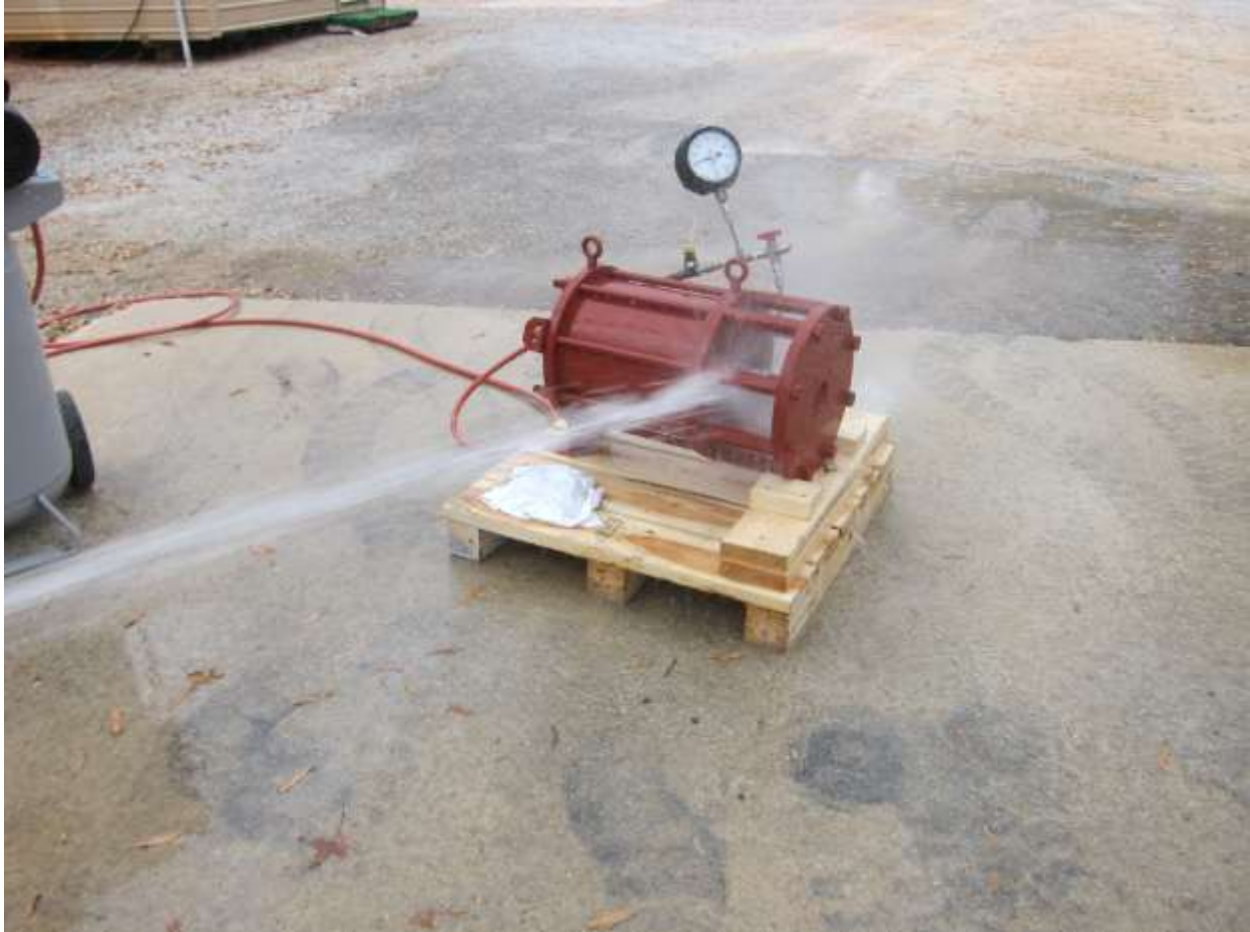
**Photograph No. 7**  
**Protection Against Ingress of Water (IP66M) Test Setup**

**Photograph No. 8**  
**Protection Against Ingress of Water (IP66M) Test Setup**

The UUT was placed on an outside test facility and subjected to a water spray from a 12.5 mm nozzle (IP6) at a rate of 100 liters/minute (211 pounds/minute) from a distance of at least 2.5 meters (8 feet), for a total duration of 3 minutes. The UUT was operated at various times during the 3-minute exposure.

A post-test visual inspection and an operational check were performed to verify satisfactory post-test conditions of the UUT. No damages were noted. No anomalies were recorded. The UUT successfully met the Protection Against Ingress of Water (IP66M) Test requirements.

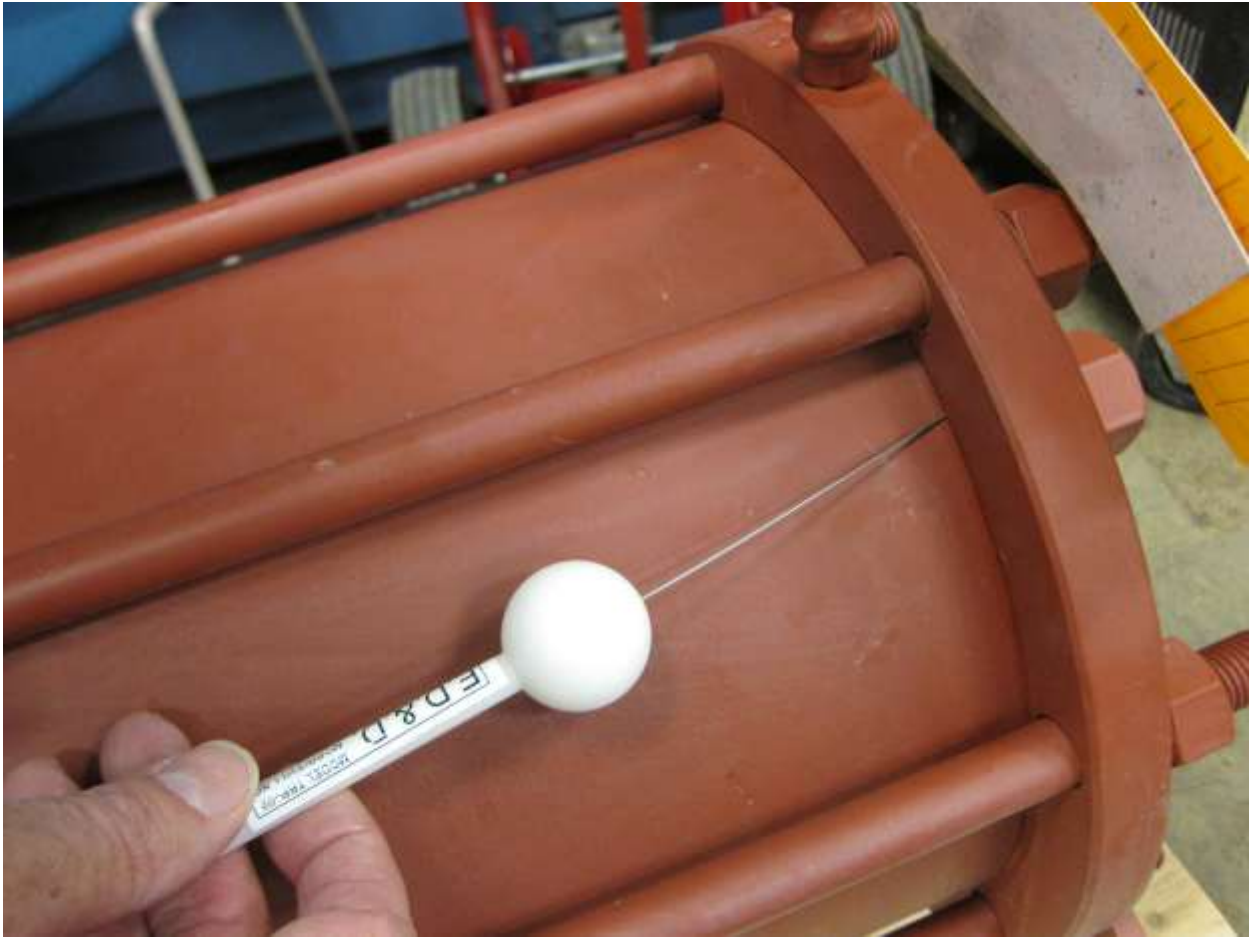
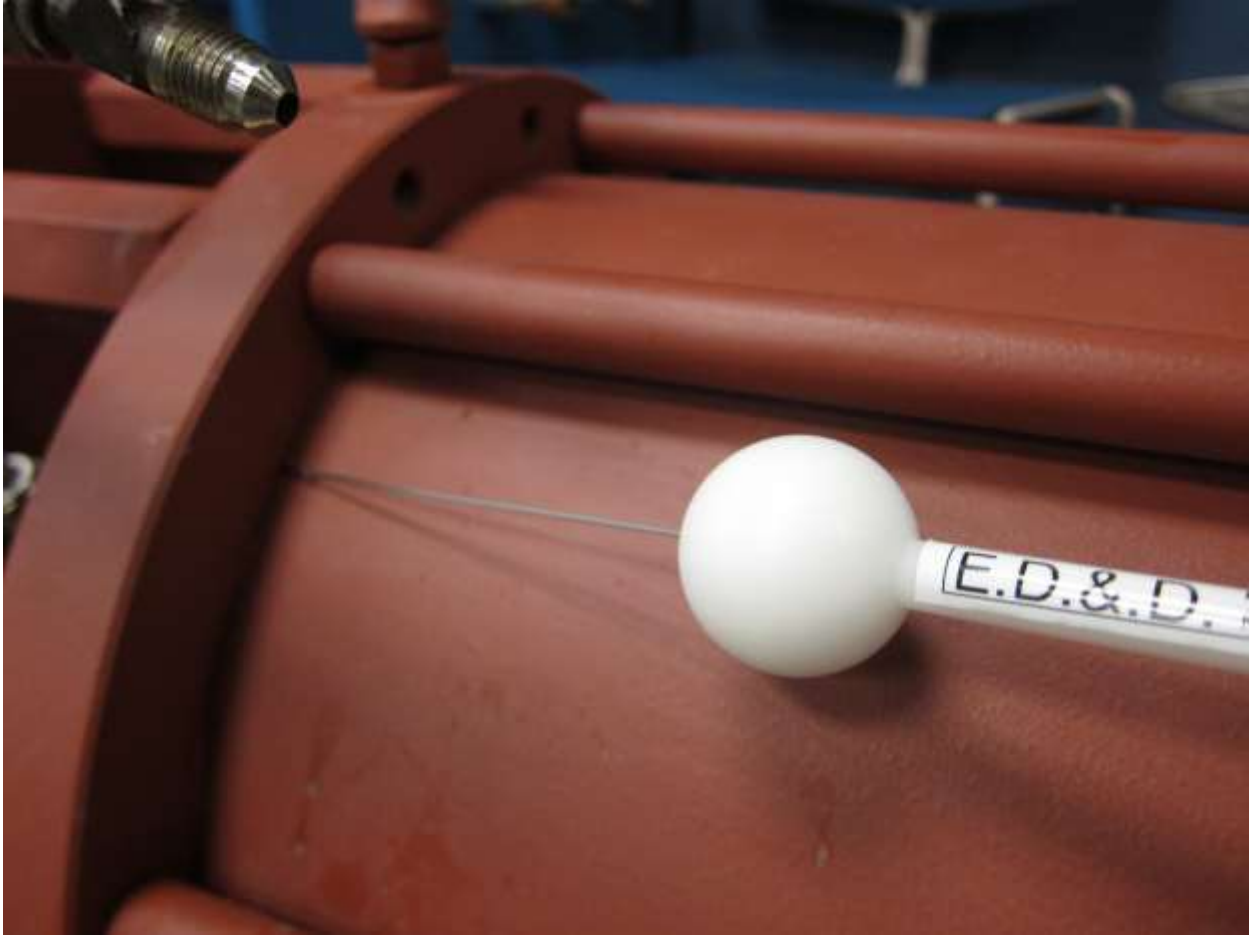
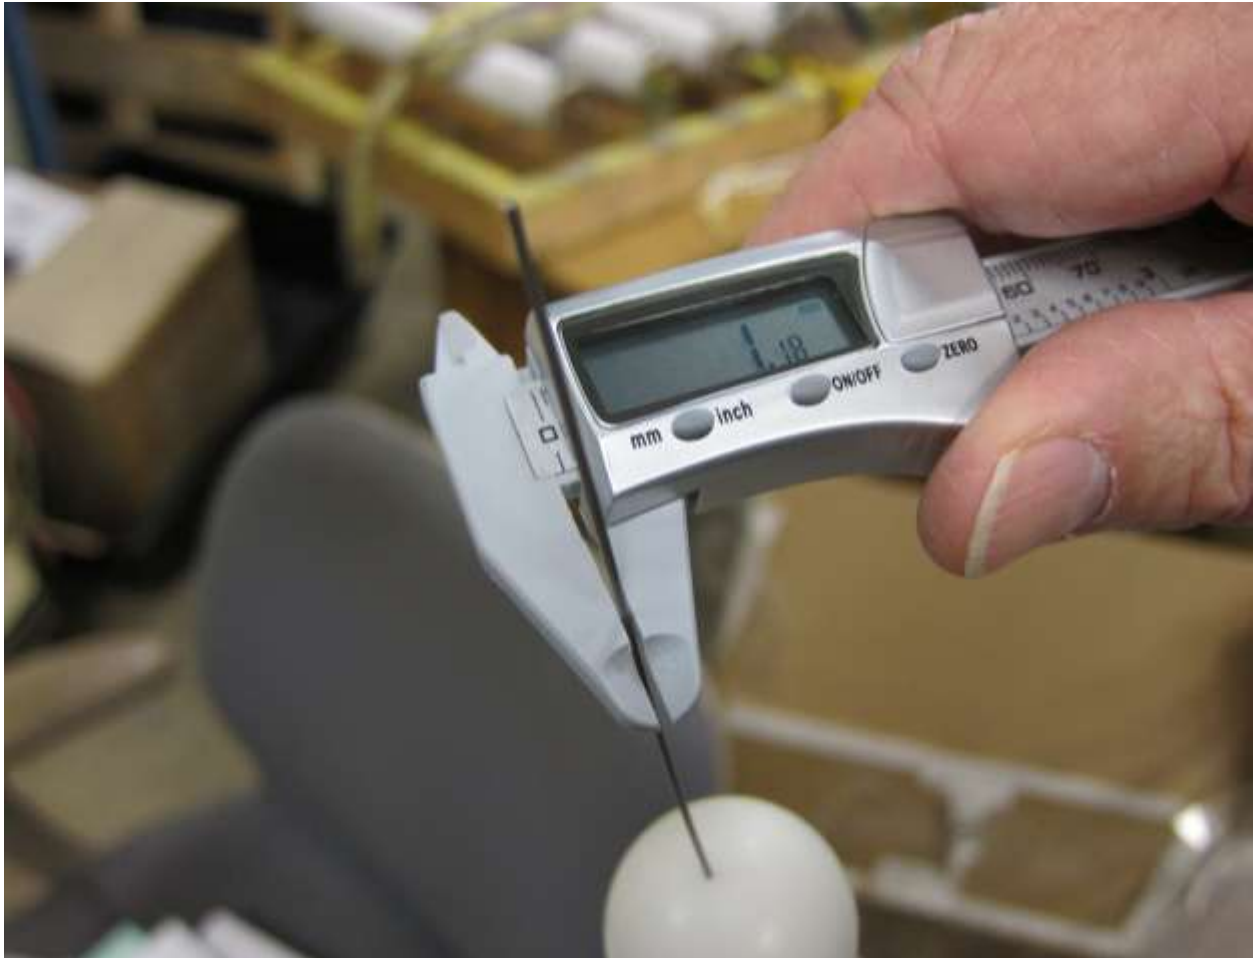
**Photograph No. 9**  
**Protection Against Hazardous Parts Test Setup**

**Photograph No. 10**  
**Protection Against Hazardous Parts Test Setup**

**Photograph No. 11**  
**Protection Against Hazardous Parts Test Setup**

**Photograph No. 12**  
**Protection Against Hazardous Parts Test Setup**

A 1.0 mm test wire was used to push against openings on the UUT that are specified in the above-referenced email. The stop face did not fully penetrate through any opening. No damages were noted. No anomalies were recorded. The UUT successfully met the Protection Against Ingress of Hazardous Parts Test requirements.

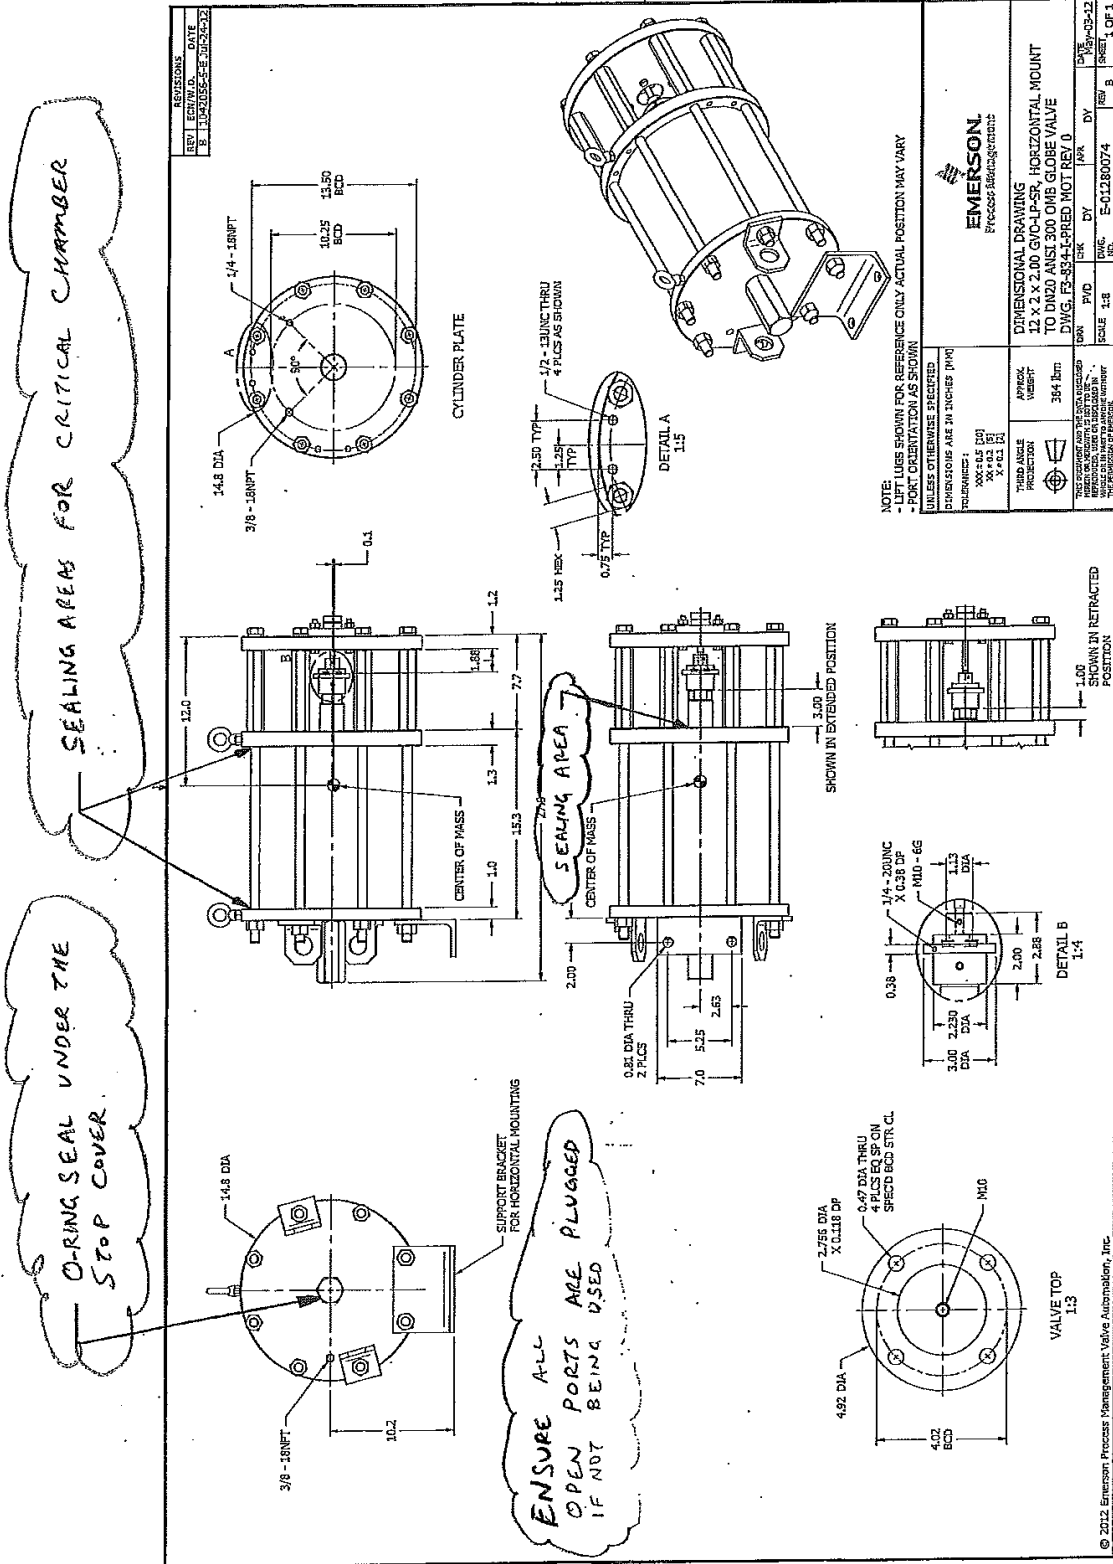
Hopefully the attached drawing helps  
I have marked the drawing for visual understanding of what we discussed on the phone

I am not sure what do you mean below  
the piston side on the actuator is critical as it is pressurized, the spring side is not pressurized
