Emerson's Bettis™ Actuation Solutions Maintain and Sustain a 20-Year-Old Deepwater Gas-to-Power Plant

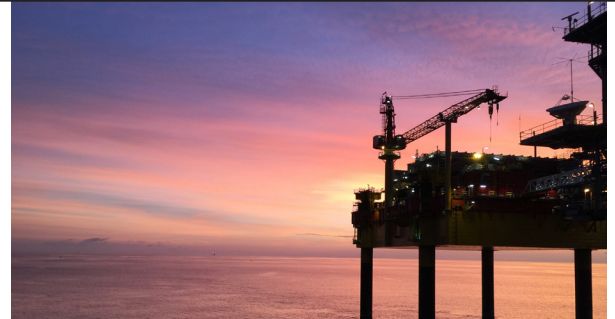
This Bettis G-Series Valve Operating System in a 20-year-old Deepwater gas-to-power plant provides plant safety and extends plant uptime.
