Using Peak Detection Monitoring on a Paper Machine Refiner

This paper describes the application of Emerson's unique approach for early peak detection – PeakVue™ technology - to better assess the machinery health of paper machine refiner equipment.

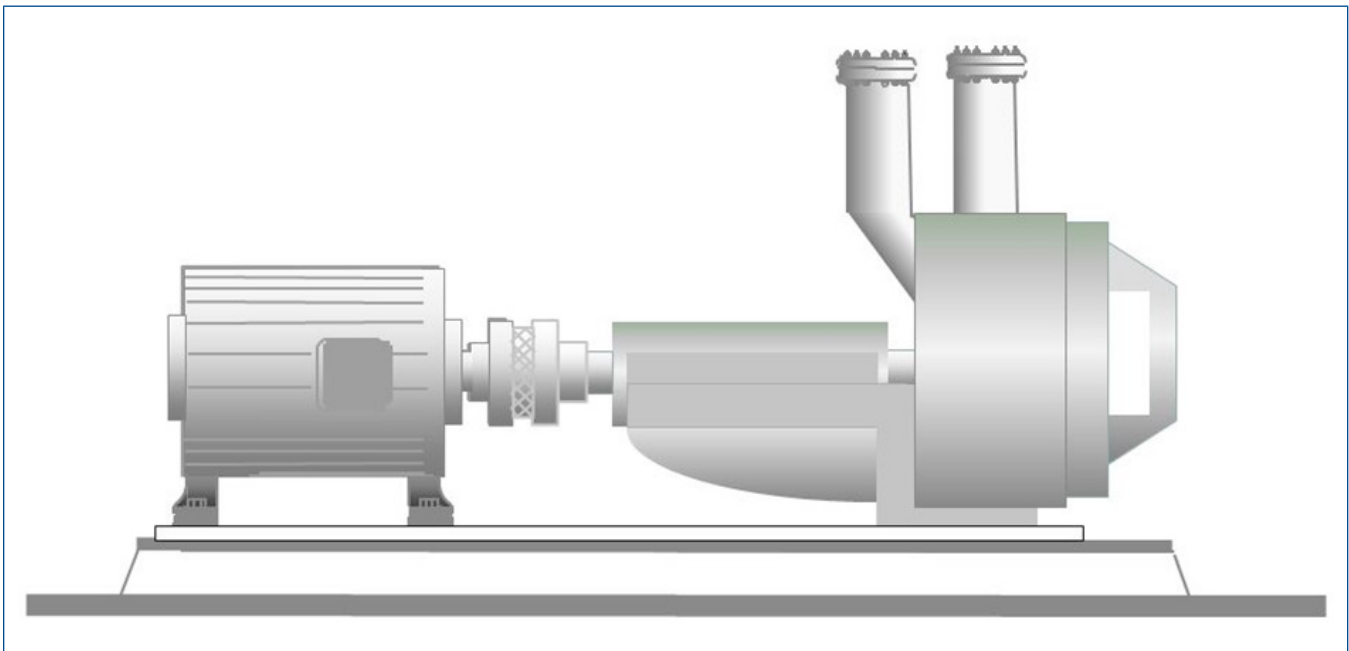
Typical Motor and Refiner Assembly

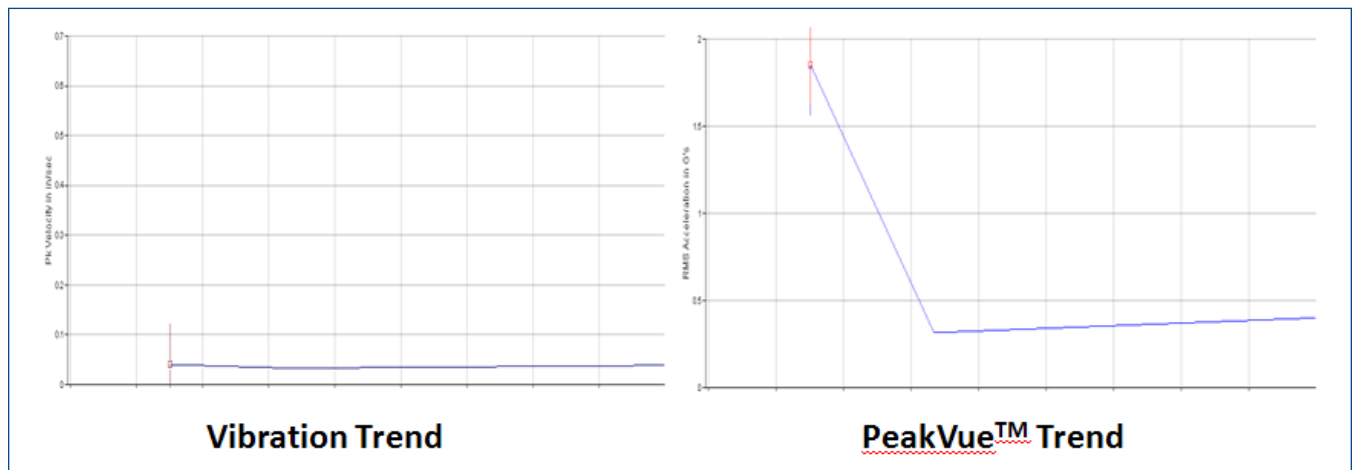
In the following trend plots, data was collected using a portable machinery health analyzer. In the vibration trend, no significant amplitude changes are observed, while the PeakVue trend plot indicates elevated amplitudes from the very first reading. The vibration trend did not change, but the PeakVue trend shows marked amplitude decrease after maintenance repairs were completed.

Vibration Trend (left) vs. PeakVue Trend (right)

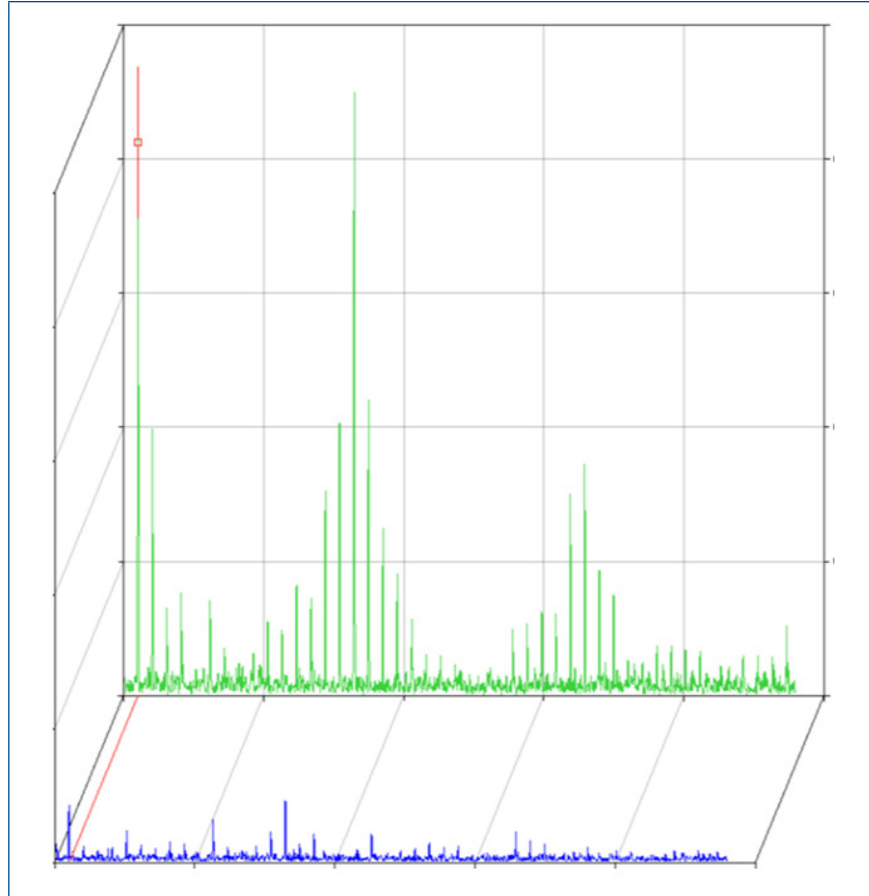
In the multi-spectrum PeakVue plot below, the 1xRPM multiples and plate defect peaks can be clearly seen before maintenance was initiated (green spectrum) and a decreased amplitude (blue spectrum) is apparent after repairs were made. The vibration spectral data did not indicate the seriousness of this refiner problem.

Multi-spectrum PeakVue Plot

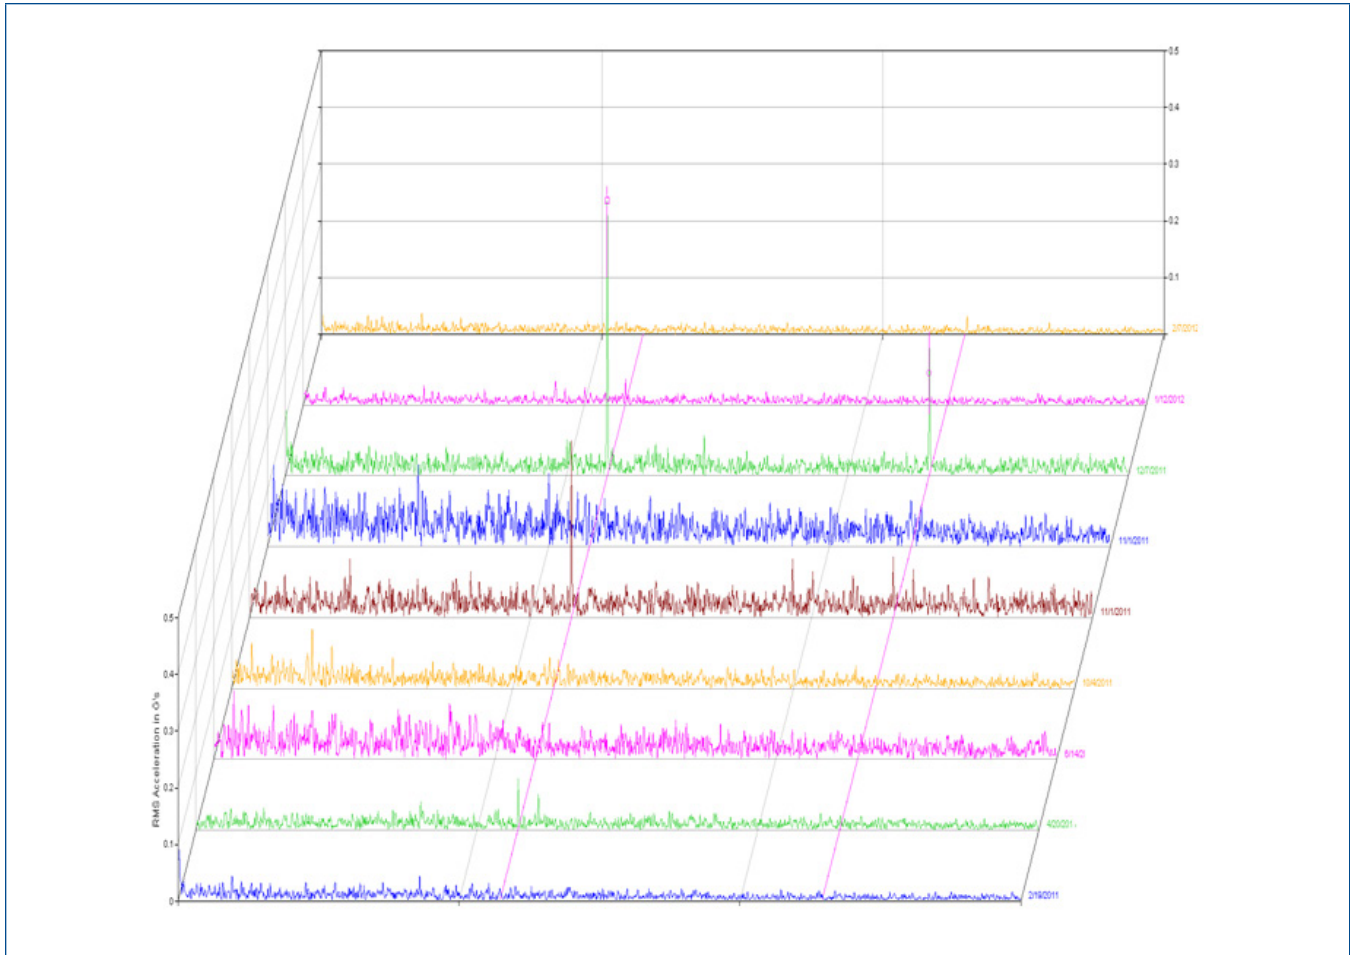
In another example, the multi-spectrum PeakVue plot below indicates two separate problems are present in the data. The first event (brown spectrum) showed elevated refiner plate defect peaks which were addressed by replacing the refiner plates. In the second event, an initial baseline PeakVue spectrum (center blue) indicated slightly elevated broadband noise. When another measurement was taken (top green spectrum) with the refiner plates loaded, the plate defect peaks were again present due to the incorrect installation of two of the refiner plates. The top two spectra were obtained after this problem was resolved and with the refiner returned to normal operation.

Multi-spectrum PeakVue Plot

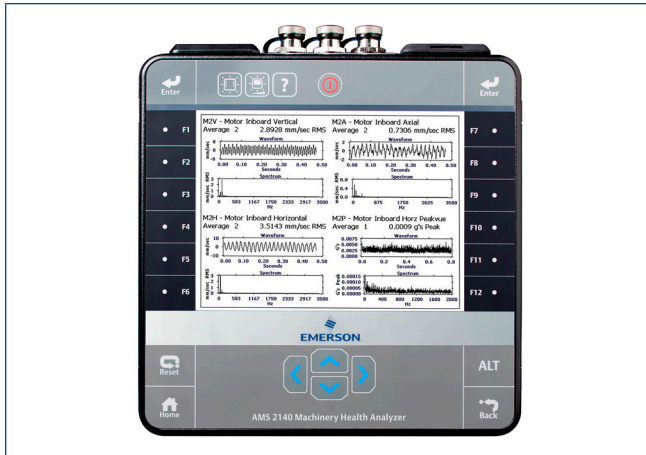
AMS 2140 Machinery Health Analyzer

While the examples above were identified using a portable machinery health analyzer, such as Emerson's AMS 2140, PeakVue is also available in Emerson's wireless vibration transmitter (AMS 9420) and continuous online monitoring system (AMS 6500).

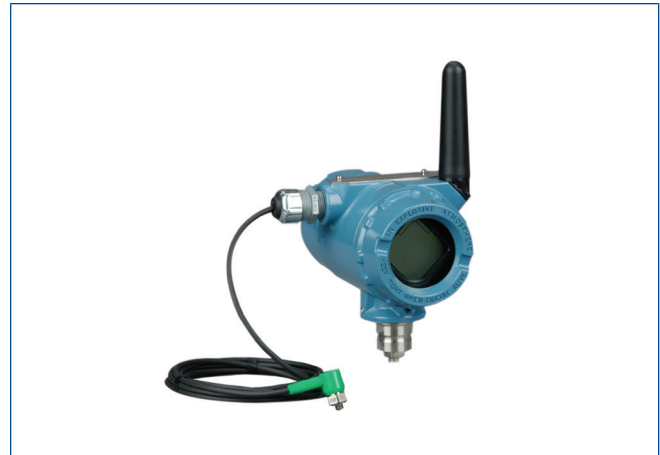
AMS 9420 Wireless Vibration Transmitter
