The case for top-entry in cryogenic LNG

Specifying top entry buttweld triple offset valve design in LNG cryogenic applications

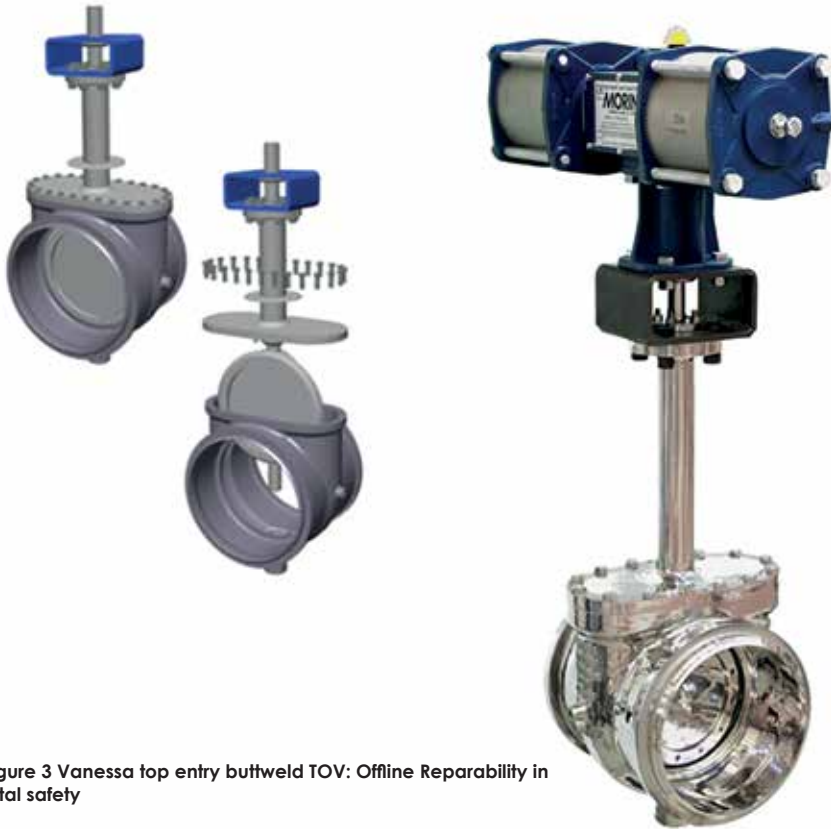
Figure 3 Vanessa top entry butt-weld TOV: Offline Reparability in total safety

The trim can be completely removed from the body and every component can be repaired or replaced (fig. 3). This means the valve is safe to repair, there is no exposure of service personnel to safety risks and there is also the possibility of addressing operability problems linked to the bearing areas.

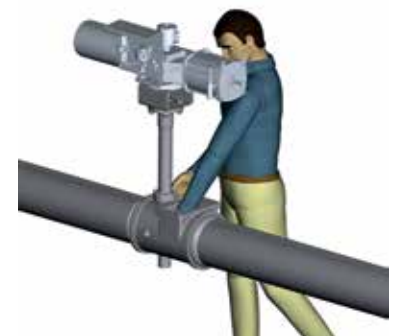
Figure 4 Maintenance of small-sized side entry butt-weld TOVs: An unfeasible task

difficult to disengage components and take them outside the port. In addition, this operation is completely unfeasible if the valve is installed at a height/difficult location to reach (fig. 4). Overall, these critical issues may jeopardise the very reason for a side entry body specification (maintenance operation), as only a visual inspection can be carried out.

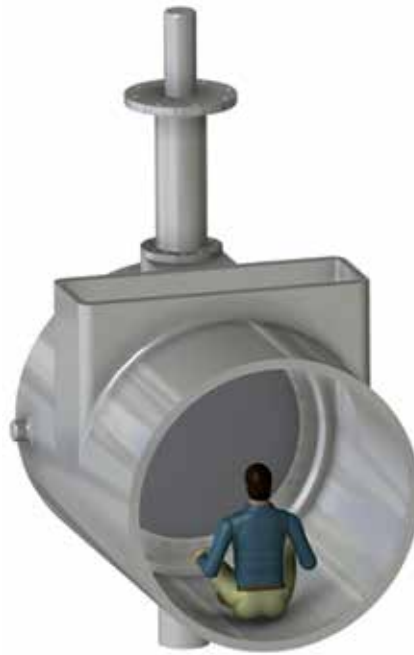
Figure 5 Maintenance of large-sized side entry Butt-weld TOVs: A risky task

Once the top flange is removed, a service representative should be let inside the conduit at extremely high safety risks including exposure to residue gas, pressurised equipment, and other factors (fig. 5).

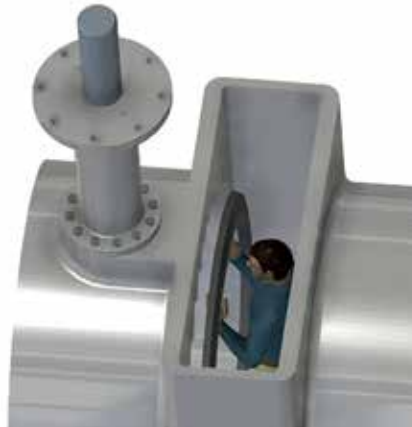
Figure 6 Risk of operator crushing during maintenance of large side entry butt-weld TOVs

Another serious risk that may remain unaccounted for during valve specification is the potential of crushing the operator during the removal of key components since lifting aids cannot be safely applied after removing bolting (fig. 6).
