US Refinery increases reliability by implementing Rosemount 8800 Quad Vortex Flow Meter in SIS application

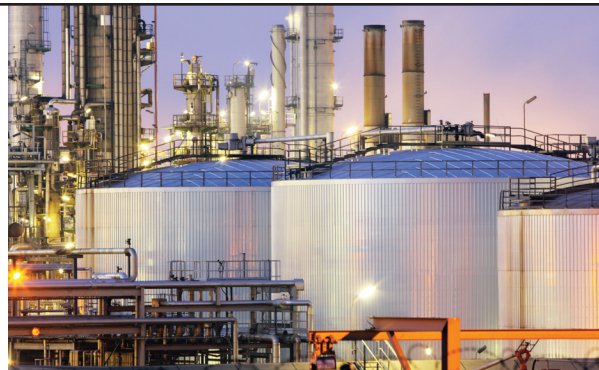
While the DP flow meters experienced impulse line freezing, the Rosemount 8800 Quad Vortex performed reliably throughout the winter and prevented a false trip of the Hydrotreater unit.

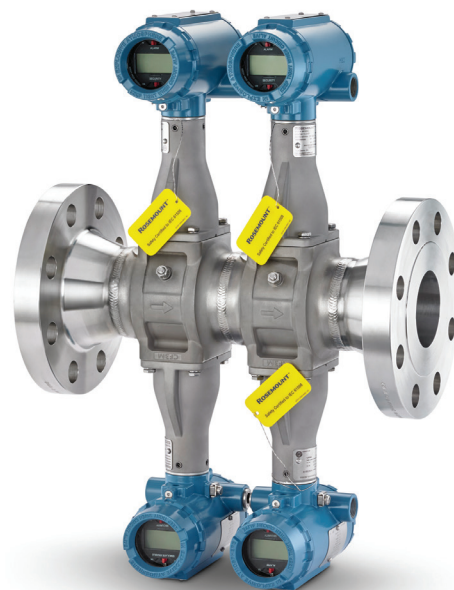
The refinery chose Vortex technology as a solution to eliminate their impulse line issues. They investigated using two dual Vortex flow meters, but this presented a problem due to the required straight pipe run. Emerson suggested using a Rosemount 8800 Quad Vortex Flow Meter that close-coupled two dual Vortex sensors with four independent measurements that also solved the straight pipe run issue. The Rosemount Quad Vortex also offered excellent rangeability with no need for zeroing and decreased operating expenses and maintenance over traditional DP flow meters.

The Quad Vortex was installed with the addition of an orifice and two DP flow meters to address SIS proven-in-use considerations. During the following winter, both DP flow meters experienced the freezing of sensing lines during the extremely cold temperatures. In contrast, the Rosemount 8800 Quad Vortex continued to function without issue throughout the entire winter, providing four independent outputs that prevented a false trip of the Hydrotreater unit. Because signals from the Quad Vortex were also being routed to Logic Solver with DP transmitters, a false trip of the unit, which could have cost several millions of dollars, was prevented.
